# Your survey report

Inspection date

24th November 2022

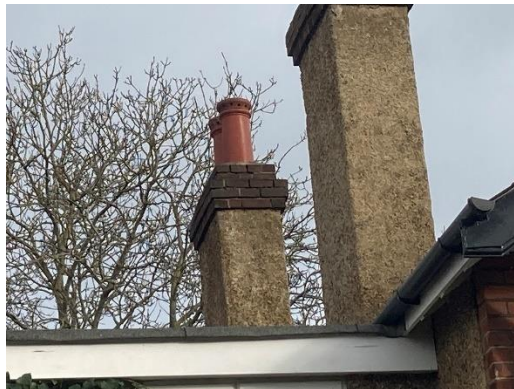
This can lead to damp penetration and potential instability of the stack. The stack now requires a thorough overhaul to include re-pointing to leave sound and weatherproof.

1 Weathered rear left hand chimney stack

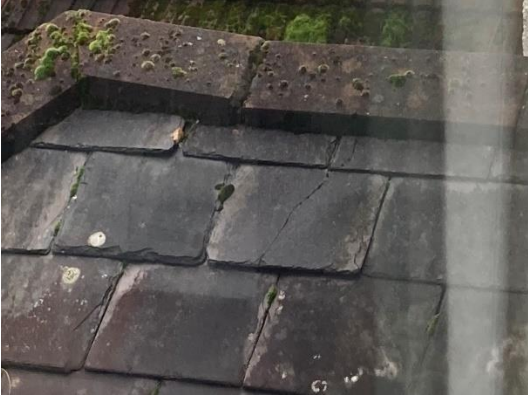
- A small number of slates were noted to be broken.
- The mortar fillet will have a limited life and should be upgraded in a more durable material such as lead.

These defects may lead to water penetration and consequently deterioration of internal elements possibly including decay of timber. The coverings now needs a thorough overhaul to leave sound and weatherproof.

2 Cracked slates to single storey rear addition roof

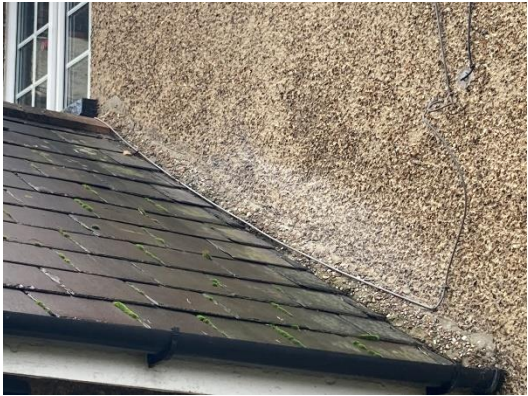
3 Mortar fillet to single storey rear addition roof

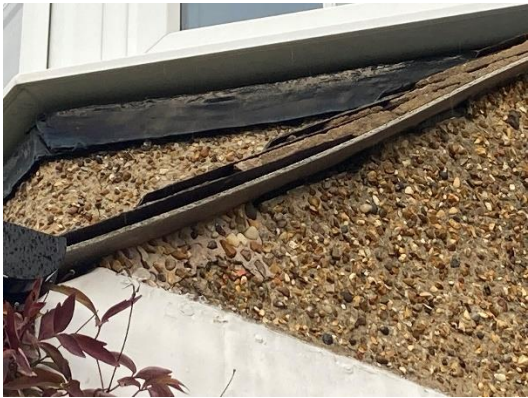
The front bay roof is pitched and covered with slates.  
Verge mortar to the slates has eroded in places and requires repair.

4 Deteriorated verge mortar to front bay roof covering

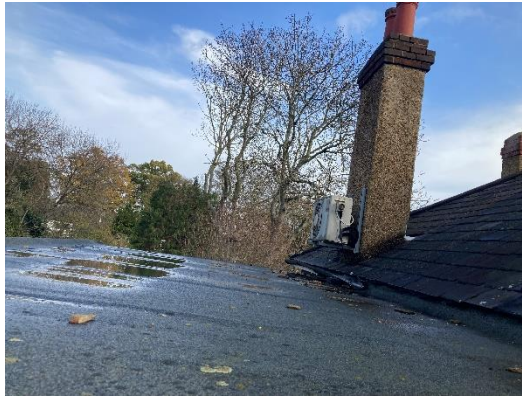
The flat roof appears to be in satisfactory condition at present with no signs of water penetration to the underside, although it was noted to be ponding slightly. Flat roofs do, however, have a limited lifespan and can be prone to sudden failure. You should anticipate and budget for ongoing repair and periodic renewal.

*5 Flat roof covering*

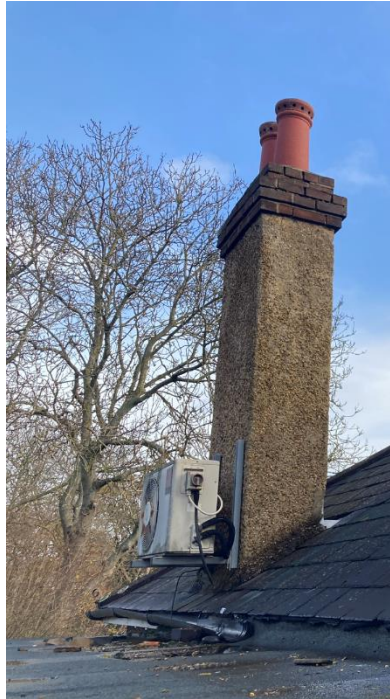
The guttering to the left hand flank wall of the original property is damaged and requires replacement.

6 Damaged guttering

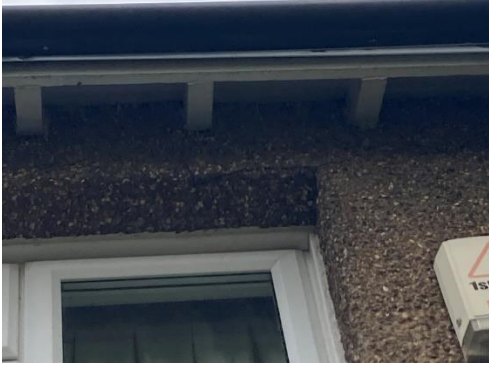
- The rendered wall surfaces are cracked in a number of places. Damaged rendering can cause dampness internally and repairs are required as soon as is practicable.
- A small number of low level bricks to the front elevation are spalled (eroded) and would benefit from repair.

7 Cracked render

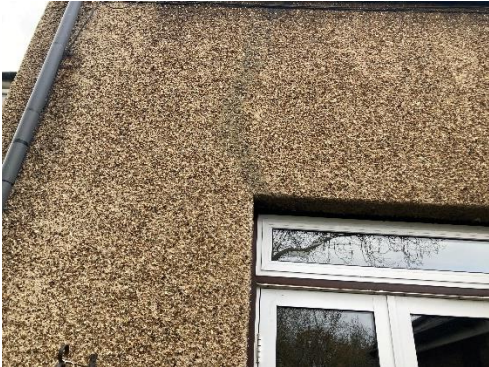
8 Cracked render

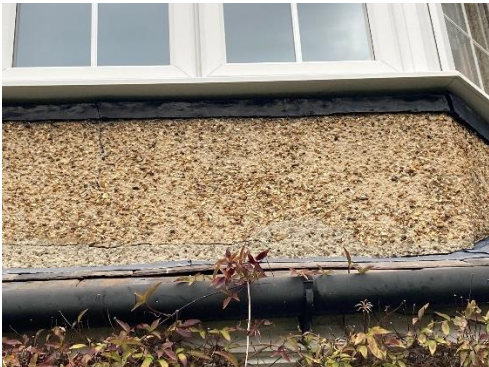
9 Cracked render

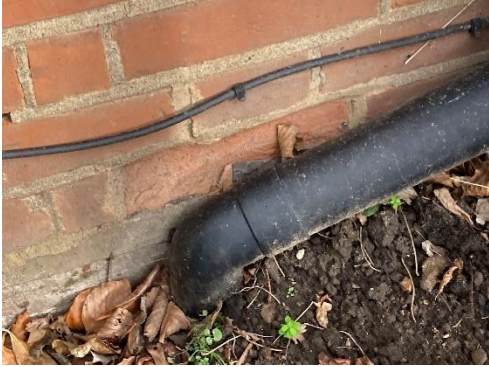
10 Spalled masonry

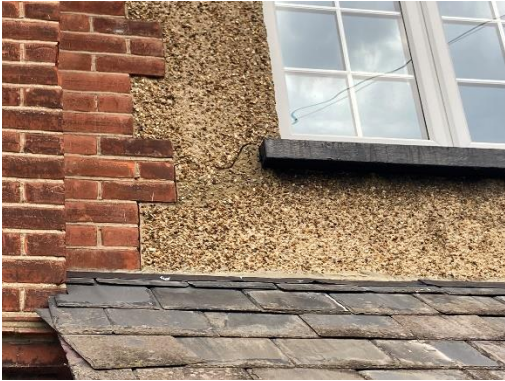
The property has been affected by past structural movement, evidenced by cracking and distortion around window openings (especially evident around the front right hand bedroom window) and also cracking between the main and front bay structure and also between the main and single storey rear addition structures. The likely cause of which is historic settlement and differential movement. From a single inspection the movement appears to be long-standing and does not appear to be progressive. However, some seasonal movement may continue due to the nature of the subsoil. No significant works are currently needed but cracks should be filled to prevent possible future water ingress.

11 Cracking and distortion

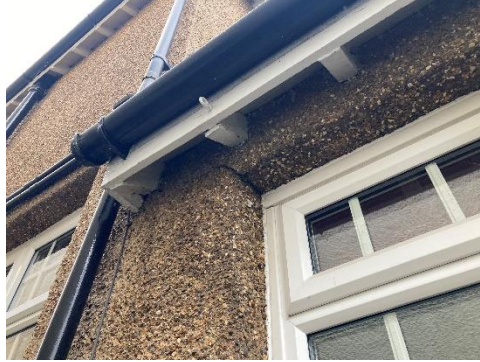
12 Cracking between main and single storey rear addition structures

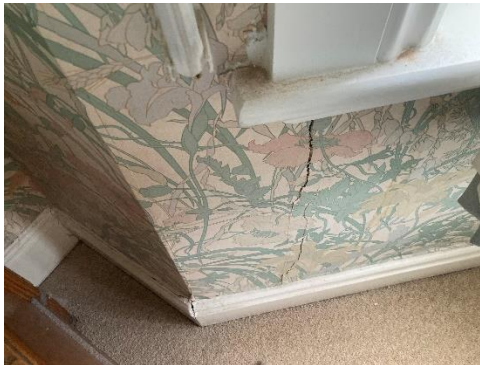
13 Differential movement to front bay structure

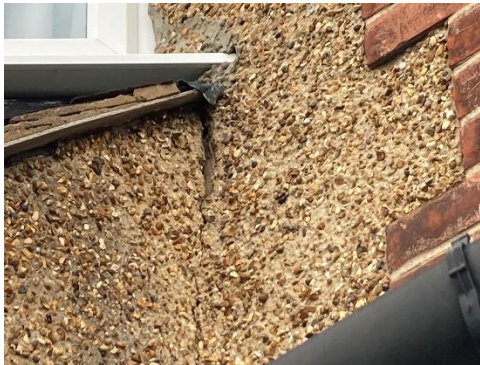
14 Differential movement evident to front bay structure

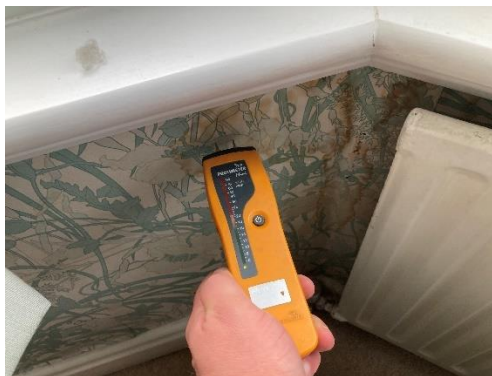
Damp staining was noted internally to the first floor front bay walls. These areas were tested with a moisture meter and were found to be dry.

*15 Dry staining*

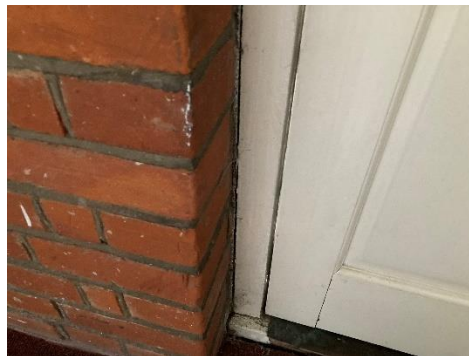
There are gaps around the front timber door frame which should be filled.

*16 Gaps around door frame*

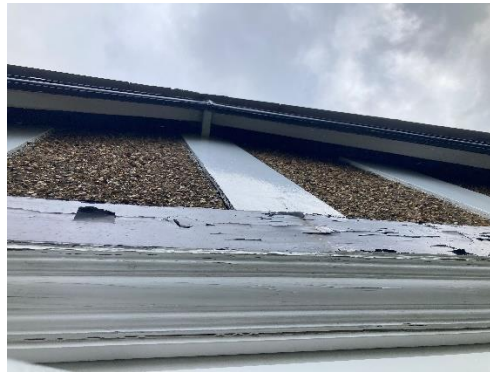
The decorative timbers to the front of the property are weathered and beginning to rot in places and require an overhaul.

*17 Weathered decorative timbers beginning to rot*

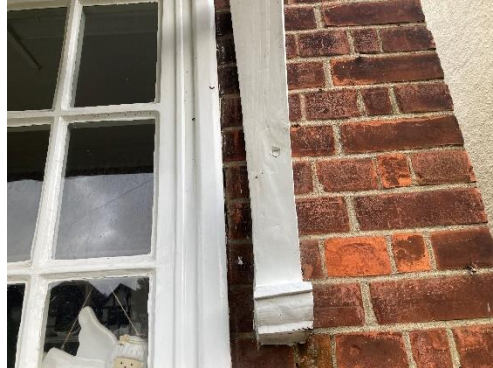
*18 Decay*

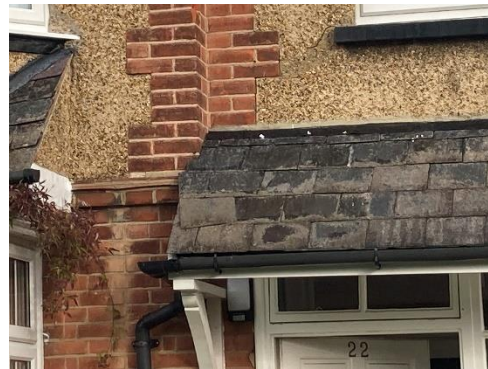
A number of slates to the roof were noted to have slipped and require repair.

*19 Slipped slates*

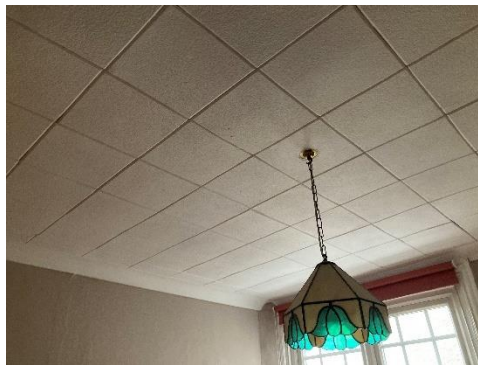
- Polystyrene tiles have been fixed to the ceiling in the breakfast room. Some types of these tiles are known to give off toxic gases in the event of fire and we recommend that they are now removed. It is probable that the removal of the tiles will cause some damage to the ceiling because of the adhesives used and you should allow to carry out some general making good and repair.

*22 Polystyrene tiles*

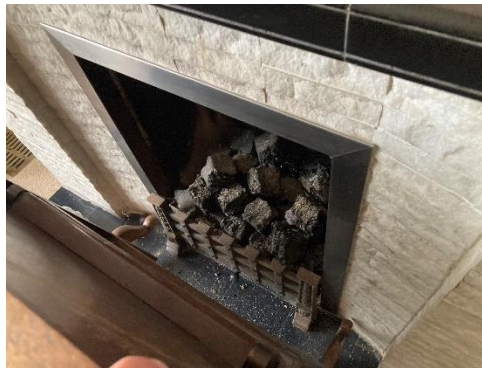
*24 Gas fire*

The gas fire must be regularly serviced and examined by a Gas Safe registered contractor to ensure both the safe and efficient operation of the appliance and the flue. The contractor should also confirm that adequate ventilation has been provided to this appliance. This should be carried out as soon as you take occupation unless a current test certificate is available.

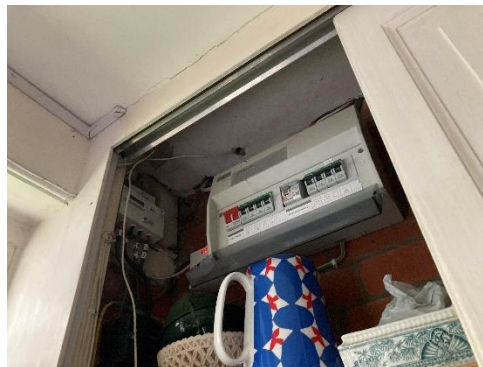
25 Meter and consumer unit

Deficiencies within the electrical installation were noted dated sockets and switch gear. The installation does not now comply with modern regulations and requires upgrading. Therefore, and in accordance with the information above and on grounds of safety, it should now be checked by an appropriate specialist prior to exchange of contracts. This report should detail all necessary works to bring the installation to current standards and the works should be undertaken as soon as practicable.

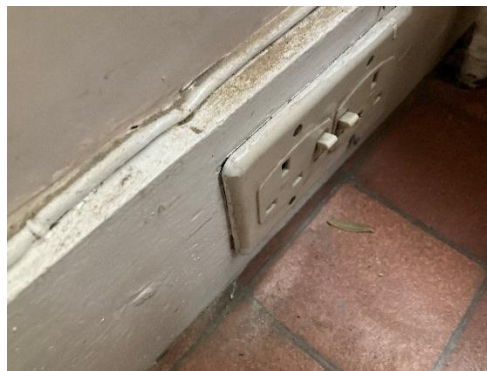
26 Dated sockets

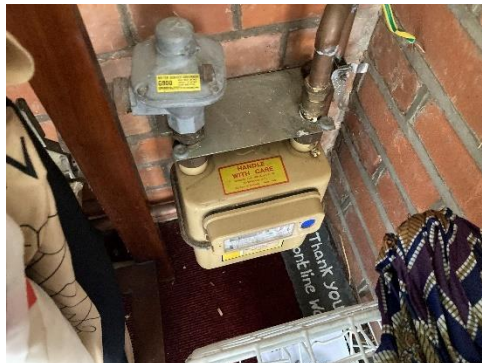
27 Gas meter

Much of the installation is concealed within the fabric of the building and, therefore, our inspection was limited to the visible parts. No testing was undertaken, and we can only advise that the installation appears to be in working order with no significant defects or deficiencies. However, if it were formally tested it may not be found to comply with current requirements. Therefore, as a matter of safety you should now arrange for the installation and all gas appliances to be inspected and tested by a Gas Safe engineer prior to exchange of contracts to confirm compliance.

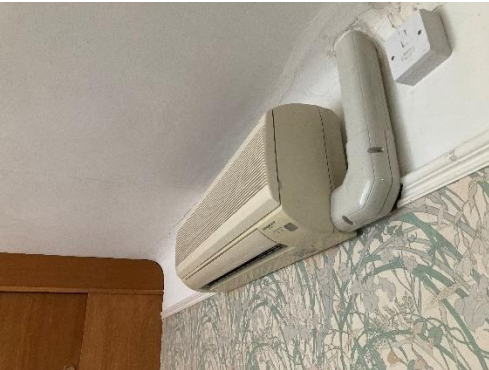
29 Air conditioning unit

There is an air conditioning unit in the master bedroom

It is essential that cooling systems are maintained in accordance with the manufacturer's instructions. Your legal advisor should check when maintenance was last undertaken and obtain the service record. Routine servicing may now be required.

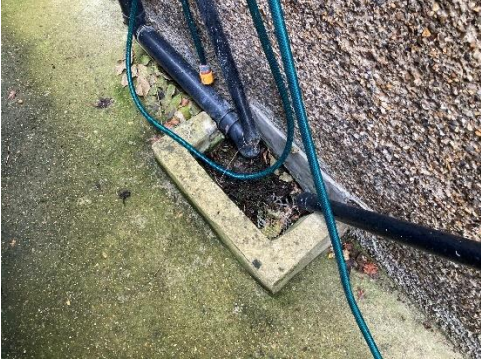
31 Blocked gully

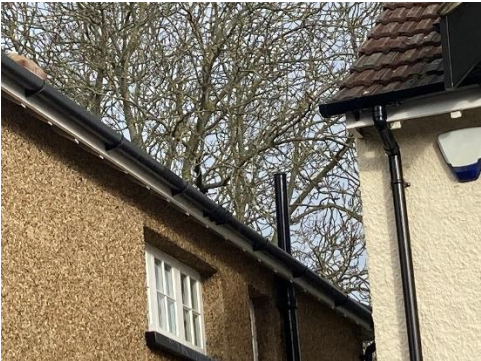
32 Uncapped soil pipe

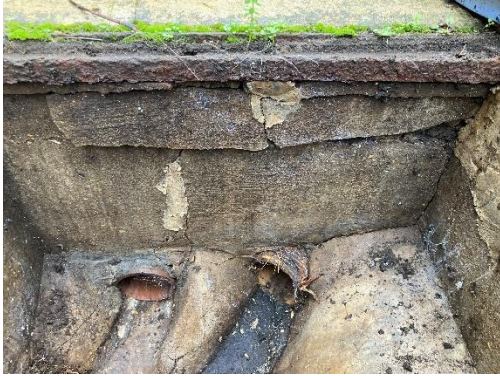
33 Cracked and damaged within drainage inspection chamber

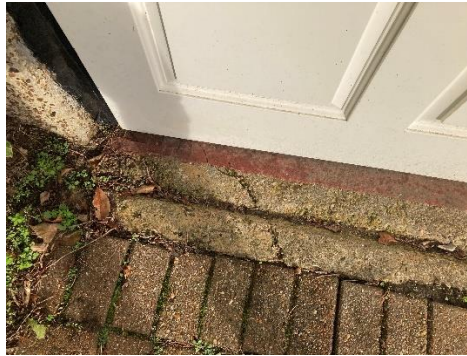
- The concrete threshold to the front of the garage is cracked.
- A small number of slipped slates were noted to the garage front projecting roof, which require repair.
- Some damaged masonry was noted around the front timber garage door frame which should be repaired. At the time of inspection, the electrically powered door did not appear to be functioning.
- The ceiling within the garage is stained which appears to be from a previous leak from the shower room above. This was tested with a moisture meter and was found to be dry but redecoration is required.

34 Cracked threshold

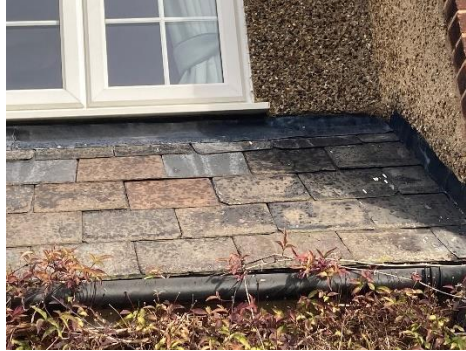
*35 Slipped slates*

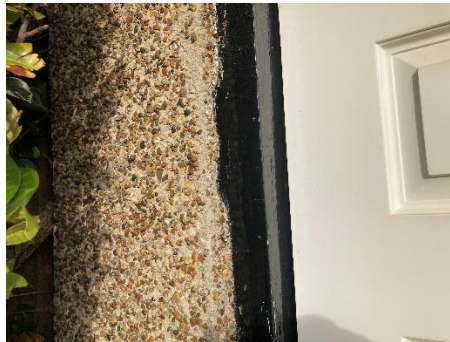
*36 Damaged masonry*

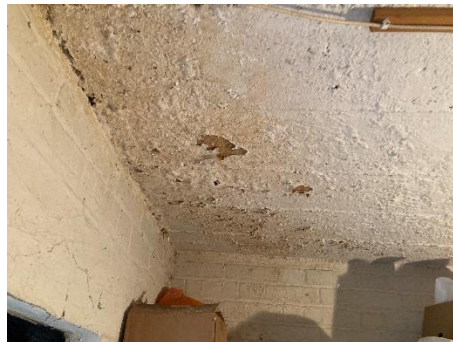
*37 Past damage to ceiling*

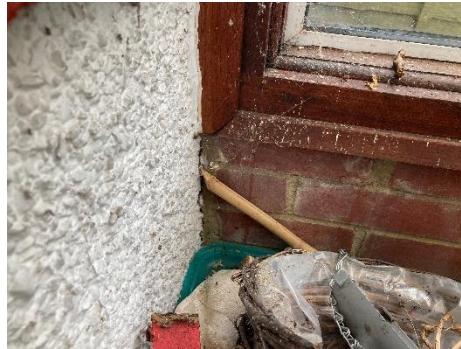
*38 Cracking between structures*

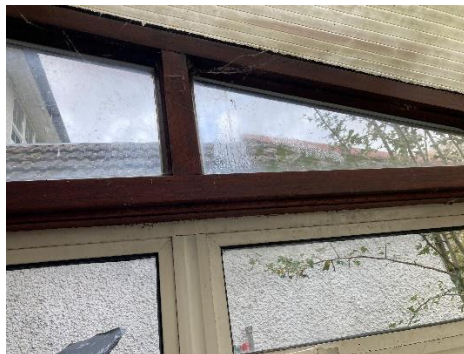
- The seals to the double glazed units appear to have failed causing misting on the glass. It is recommended that all units are checked and replaced as necessary in due course.

*39 Failed double glazed seals*

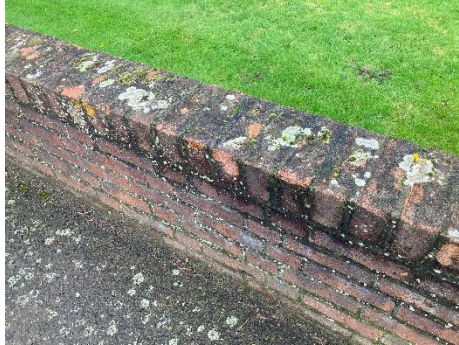
*40 Weathered front boundary wall*

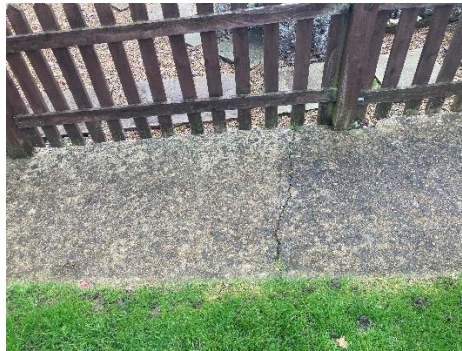
*41 Cracked path*

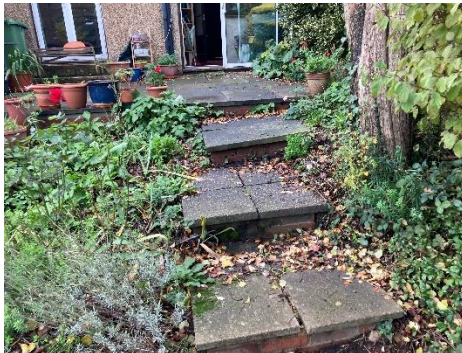
*42 Loose uneven stones to patio/steps*

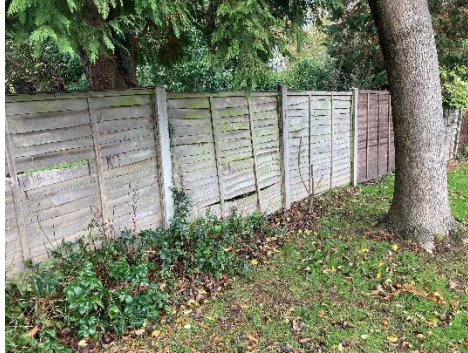
*43 Damaged fencing*
