# Your survey report

Inspection date

24th November 2022

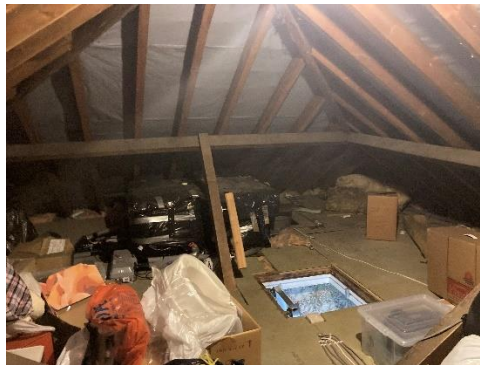
20 Main roof structure

- Current Building Regulations require insulated and lined roofs to be ventilated to prevent condensation within the roof void. In severe cases a lack of ventilation can result in decay to timbers. The roof voids do not appear to be sufficiently ventilated and fixed air vents should now be installed.
- To prevent unnecessary heat loss, insulation is usually installed over the ceilings in the roof void. Insufficient insulation is provided within the roof voids. You should now ensure that insulation is provided here to current standards and that it does not interfere with ventilation.

From the inspection possible, we were able to determine that the timbers are of appropriate size and configuration to bear their dead and imposed loads, and we noted no signs of significant deflection or movement. There is some splitting/warping to the roof timbers which occurs naturally over time and is not considered to be of structural concern at present.

Timber used in construction can undergo some splitting and/or warping which may occur naturally over a period of time due to a reduction in moisture content. This does not normally affect its structural integrity except in exceptional instances.
